YSGOL COED MAWR, BANGOR; ARBORICULTURAL IMPACT ASSESSMENT

**Report Ref: RTA.30.01
January 2023**

**Ysgol Coed Mawr, Bangor
Arboricultural Impact Assessment
Report Reference: RTA.30.01
Version 3.0
January 2023**

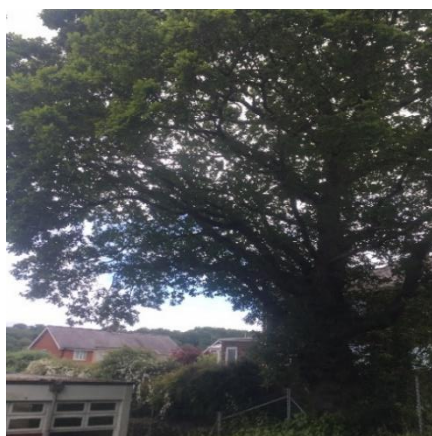
Image 1: Tree T2, mature sessile oak

- 4.3 The most significant tree within influencing distance of the site is T2, a mature sessile oak standing on the southern site boundary. This tree is assumed to be a former field boundary feature remaining from previous agricultural land use and contributes substantial visual amenity to the area. It has a broad and vigorous crown and several pruning wounds on the main stem which have occluded well indicating good vitality. Minor dead wood was observed throughout the crown typical of tree of this maturity and species.

- 5.4 With suitable protection during construction, the most prominent and valuable of the surveyed trees, T2, will be retained and incorporated into the development. It should be noted that the original layout proposal was amended to enable the healthy retention of this tree, reducing the space available for the retention of T1.

- 7.3 A number of items of tree work are recommended to facilitate the proposals and as general sound tree management.
- 7.4 It is recommended that dead wood >30mm is removed from tree T2 to prevent future shedding within the rear gardens of the proposed properties.
- 7.5 Trees T8 and T9 and group G1 overhanging the site by several meters. It will be necessary to crown raise these trees in line with the site boundary to approximately 3 meters. Liaison with the tree owner should be carried out prior to this.
- 7.6 All tree work should be carried out by a qualified contractor working in accordance with *BS 3998: Tree Work: Recommendations* and ideally take place prior to the main construction phase.

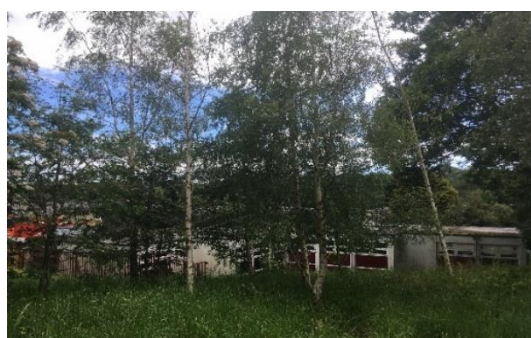
Image 2: Ornamental birch and rowan in the west of the site

- 4.4 In the easternmost corner of the site stand several middle aged ornamental broadleaved trees. These are entirely silver birch and rowan (trees T4, T5 and T6 and groups G3 and G4) and vary in condition with a small number of trees displaying advanced crown decline. Tree T5 is the highest quality tree within the group, being the most dominant and vigorous.

- 5.3 The cluster of trees in the far west corner of the site are suitable for the previous land use. Their retention would unduly constrain the construction of a new play area in this space and their removal and replacement with an appropriately configured planting scheme would be preferable to retention.

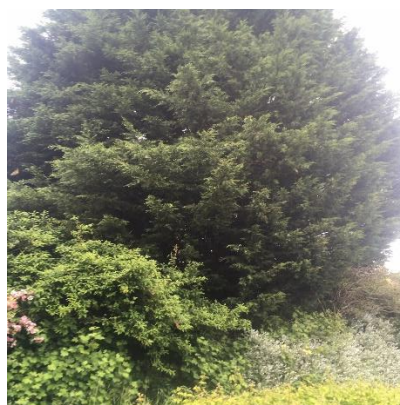
Image 3: Trees T8 and T9: Dense Lawson cypress on neighbouring land

- 4.6 A number of Lawson cypress trees (trees T8 and T9 and group G1) were recorded on third party neighbouring land during the survey. These are dense, vigorous trees typical of the species and overhanging the site by up to 3m. Surface roots from G2 were observed protruding into the site.

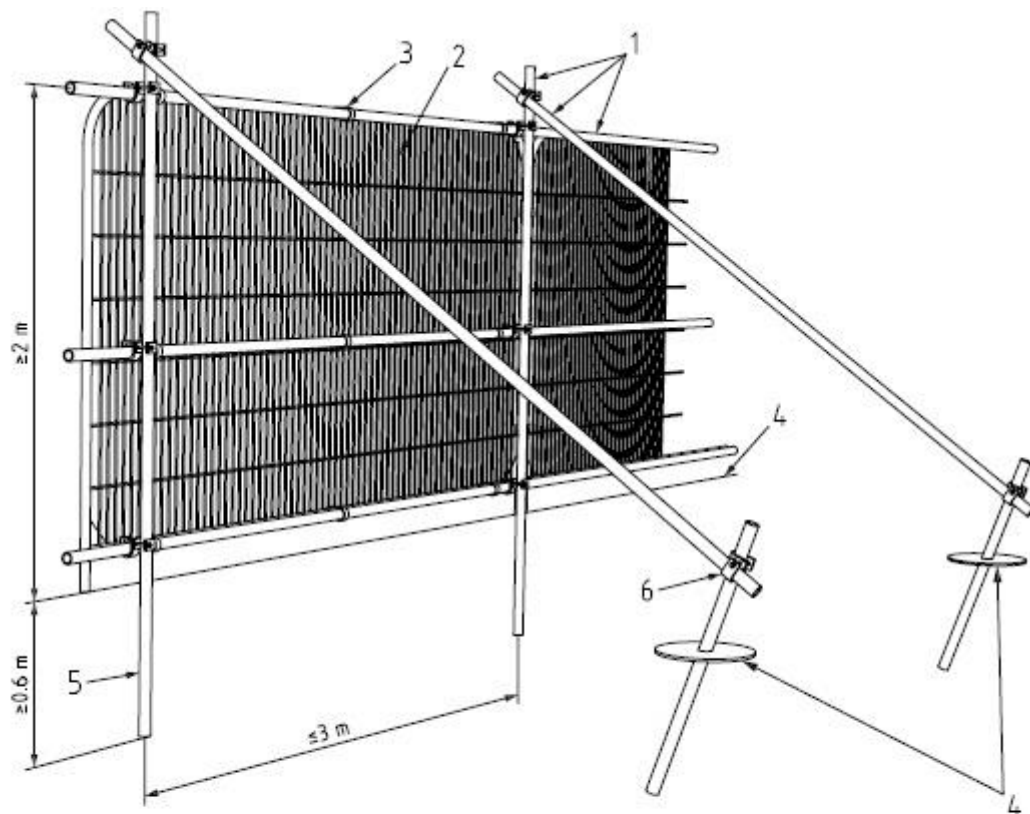
TEMPORARY TREE PROTECTIVE FENCING EXAMPLE

- 1 Standard scaffold poles
- 2 Heavy gauge 2 m tall galvanized tube and welded mesh infill panels
- 3 Panels secured to uprights and cross-members with wire ties
- 4 Ground level
- 5 Uprights driven into the ground until secure (minimum depth 0.6 m)
- 6 Standard scaffold clamps

- 6.5 Temporary protective barrier fencing will be required to demarcate a **Construction Exclusion Zone (CEZ)** around retained trees. This must be put in place prior to the commencement of any development works, including bringing machinery or materials onto site, the erection of site huts or demolition of the existing house.
- 6.6 The **CEZ** acts to protect both tree roots and branches and has been extended to incorporate canopy spread where appropriate.
- 6.7 Protective fencing alignment is shown on Drawing 2.

- 6.8 The fencing must be fixed into the ground to withstand accidental impact from machinery and to ensure that a sufficient protective area is maintained. A weatherproof notice stating 'Construction Exclusion Zone – Keep Out' must be fixed to each fencing panel. Details of recommended protective fencing are shown in Appendix 3.
- 6.9 Any alteration to the fencing alignment to allow for approved activities will be made in agreement with the council's Arboricultural Officer.
- 6.10 The protective fencing must not be removed until the physical construction phase has been completed and all vehicles have been removed from site, to the satisfaction of the council's Arboricultural Officer.

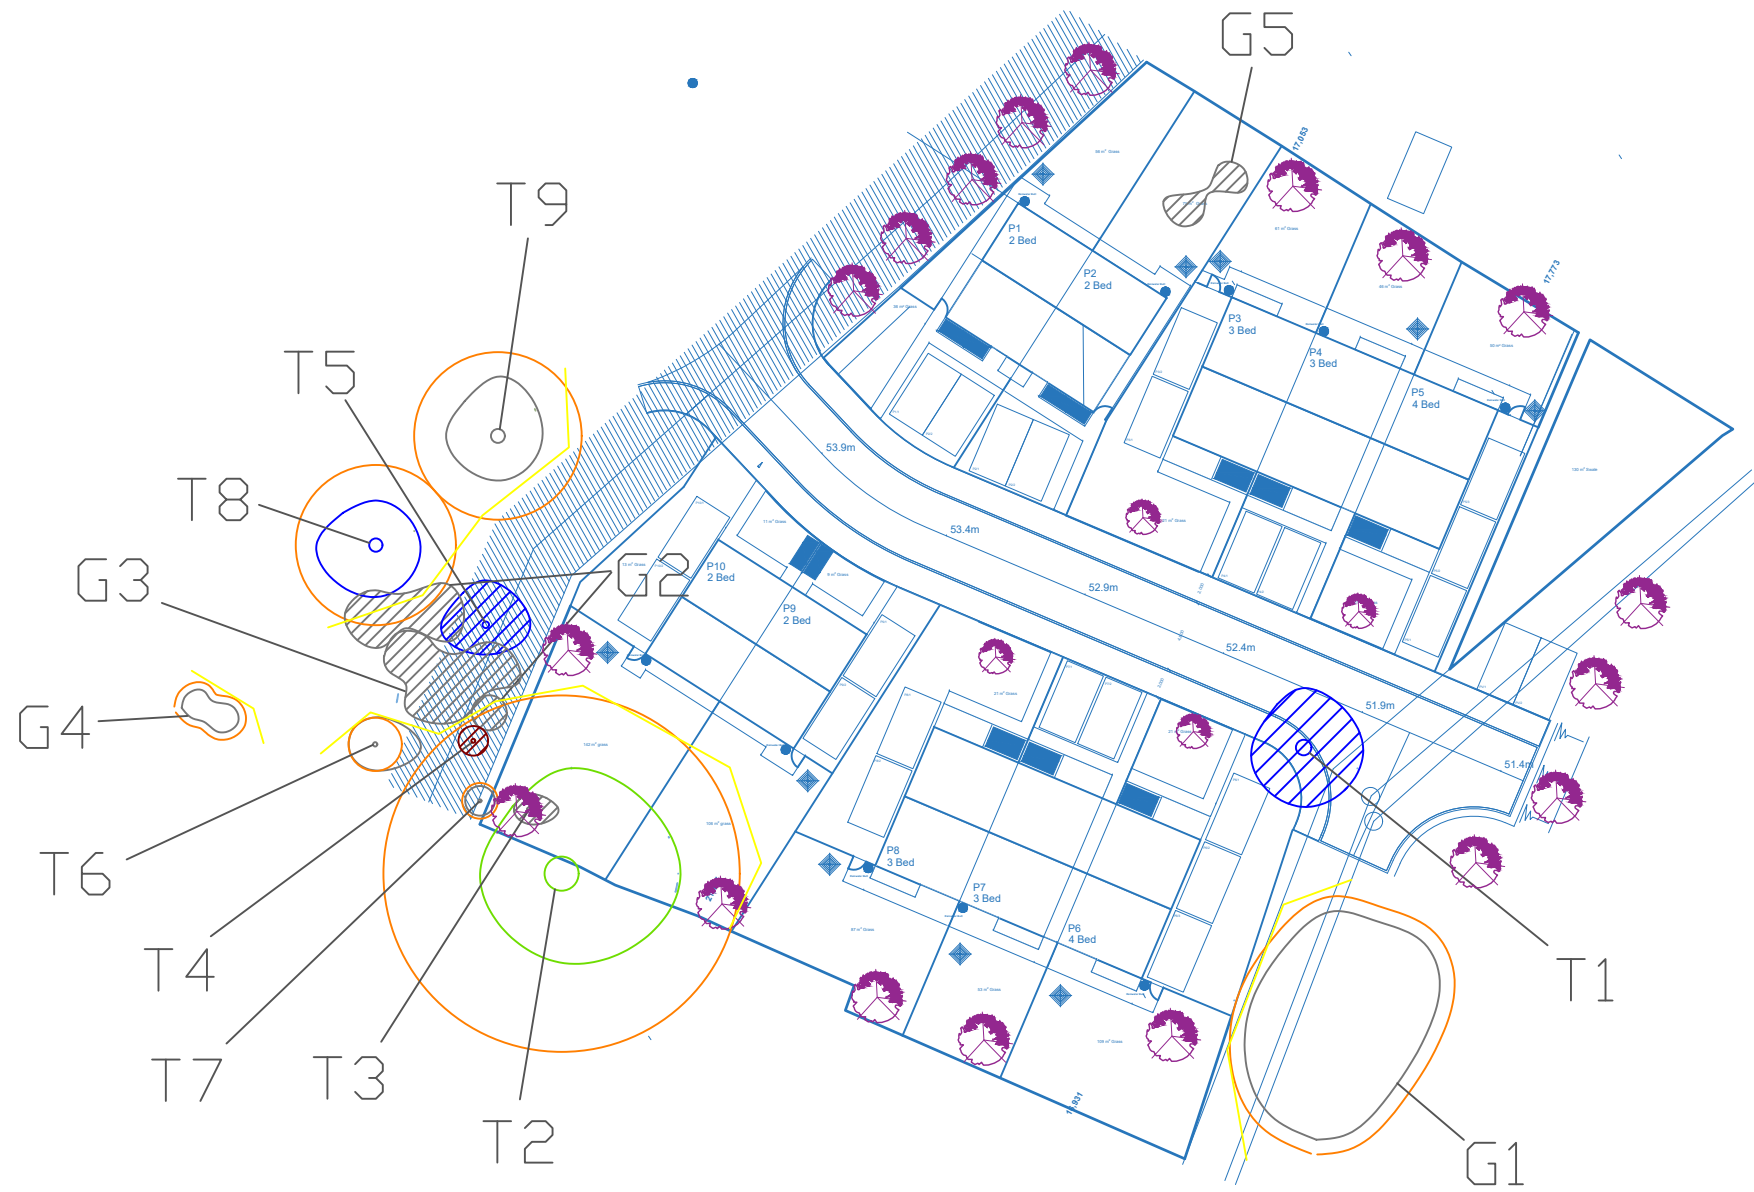
TREE IMPLICATIONS AND PROTECTION PLAN

- A Tree Implications and Protection Plan detailing the development proposals, trees to be retained and removed, tree protection fencing alignment and areas of specialised ground treatment (Drawing 2).

- T1 Individual trees
- G1 Groups of trees
- Design proposal
- Protective fencing alignment
- Mitigation tree planting

- 7.8 There will be suitable space within the front and rear gardens of the new properties for the establishment of several new trees of small to medium mature size mature crown dimensions. These areas are marked in Drawing 2. Recommended species for these areas include field maple (*Acer campestre*), domesticated pear (*Pyrus communis*) and magnolia (*Magnoliaceae sp.*).

- 7.9 Grass verges and site peripheries also feature space for the potential planting of trees of a medium to large mature size. These areas are also shown on Drawing 2. Suitable species include Scots pine (*Pinus sylvestris*), walnut (*Juglans regia*) and silver birch (*Betula pendula*).
