YSGOL BABANOD COED MAWR, BRON Y DRE, BANGOR, LL57 4TL

GEOTECHNICAL, GROUND PERMEABILITY AND CONTAMINATION INVESTIGATION REPORT

REPORT No. E1321.GGCI.R1

FEBRUARY 2021

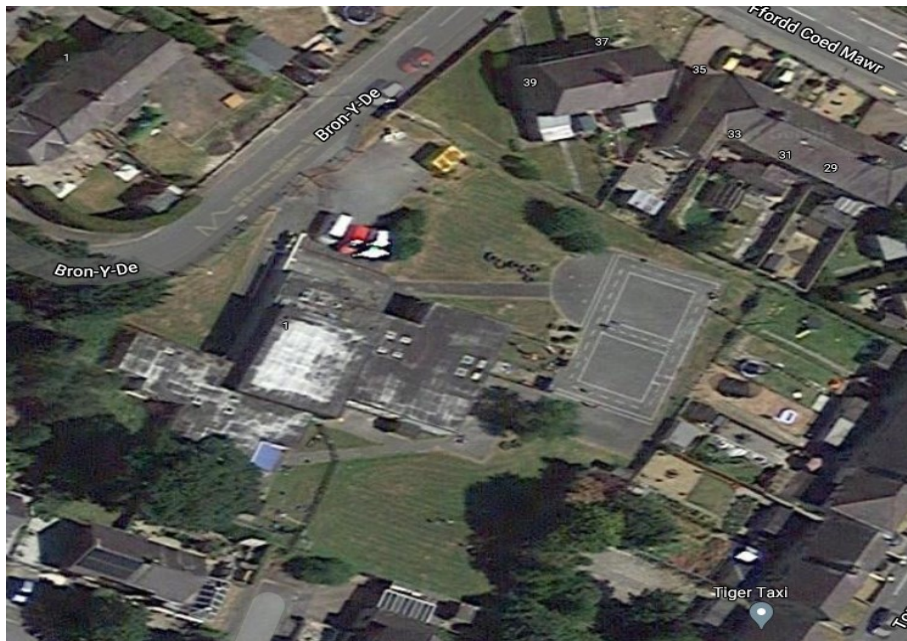
Figure 3 -Aerial Photograph

- 2.2.1 The area for investigation (site) presently comprises a former school building surrounded on all sides by either a tarmac surfaced school yard/playing area or grass playing areas. The site has a slight gradient from the north west to the south east and is at a similar elevation to the surrounding ground. The only structure on the site is the single storey school building which occupies around half of the site. An aerial photograph of the site area is shown as Figure 3.
