**Ysgol Coed Mawr, Bangor  
Ecological Survey  
Updated Report**

**25<sup>th</sup> March 2024**

**Client:** Gwynedd Council, c/o Rhys Carden, Building Development Officer, Property Development Unit

**Grid Reference:** SH 56633 70767

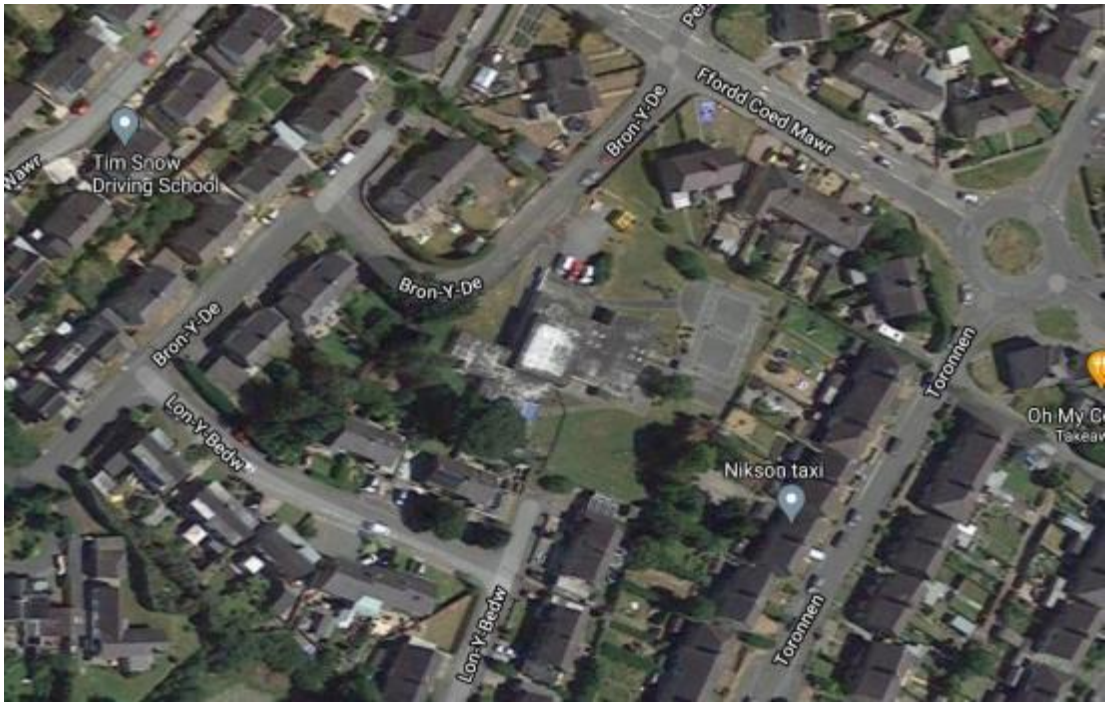
Fig.2: Aerial photo of habitat surrounding Ysgol CoedMawr

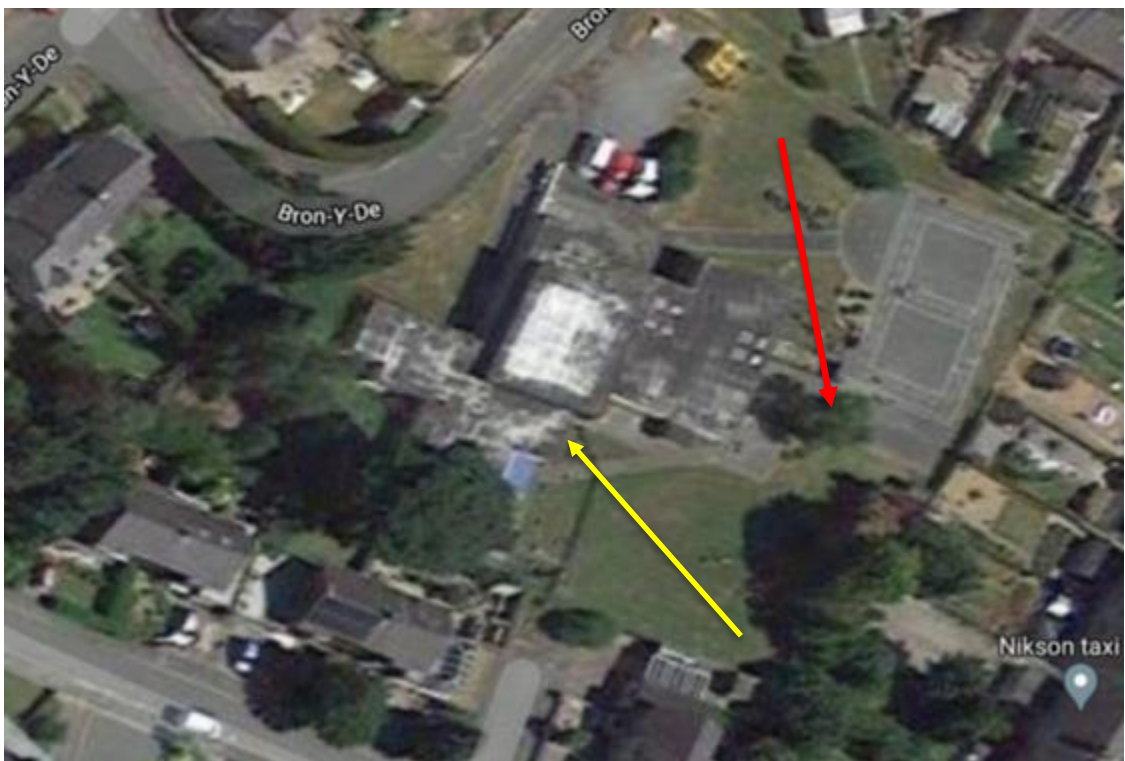
Fig.3: Location of small patch of Montbretia (red arrow) and Rockspray cotoneaster (yellow arrow)

These areas include the Montbretia and Rockspray cotoneaster. The small patch of Montbretia was located underneath a mature birch tree, while the cotoneaster was against the southern section of the building, see Fig.3 below. The birch tree had no cracks or crevices that could support roosting bats.

It is recommended that the Montbretia on the site is treated with an appropriate herbicide prior to demolition or ground-works commencing, both of which could result in the dispersal of the plant.

For this to be effective, the plant must be excavated to a depth of a minimum of 75cm and a minimum of a 75cm radius from the plant to ensure that all corms have been removed.

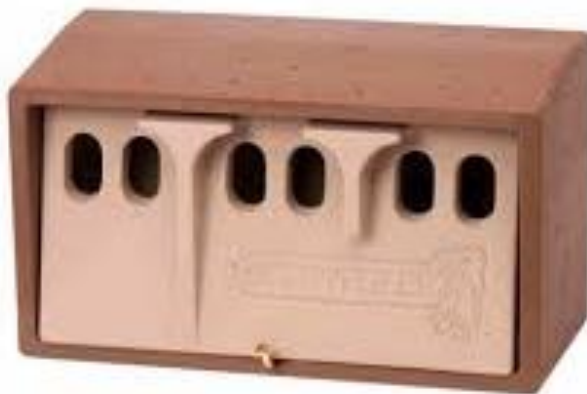
It is recommended that a total of five house sparrow colony boxes are erected as high as possible on the north facing elevations of buildings 1-5 (see Figure 4). This elevation is chosen in order to prevent overheating in the summer and to protect the boxes from prevailing weather. It is recommended that ‘Woodcrete’ or ‘Woodstone’ products such as the 1SP Schwegler Sparrow Terrace are used due to these materials favourable longevity and insulative properties.

Fig. 5: An example of an appropriate house sparrow terrace box

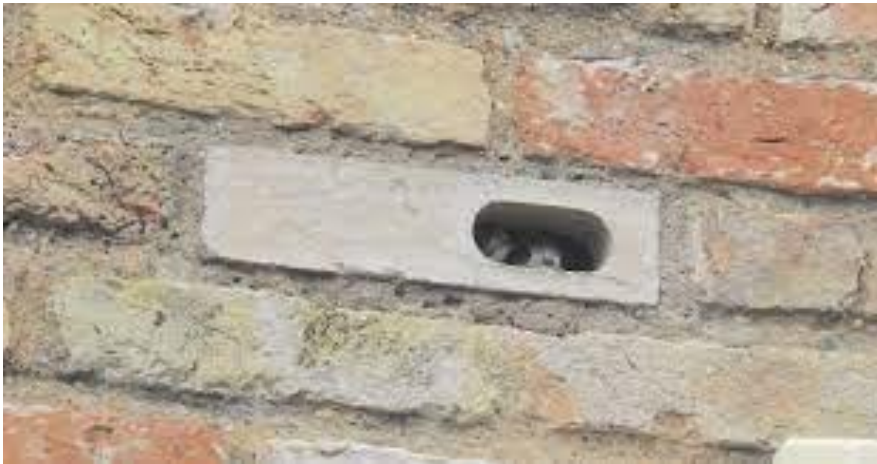
It is recommended that a total of eight swift bricks are included in the fabric of the works. These should be installed as high as possible with two on each of the west facing gable ends of houses 1 and 6 and two on each of the east facing gable ends of houses 5 and 10 (see Figure 4). These locations have been chosen due the necessity of such features to be as high as possible off the ground and have at least 5m clearance in front

of their entrances. It is recommended that integrated products such as the Pro UK Visible Build-In Swift Box are used as these products are discrete and are unlikely to be removed by feature residents.

Fig. 6: An example of an appropriate swift brick product

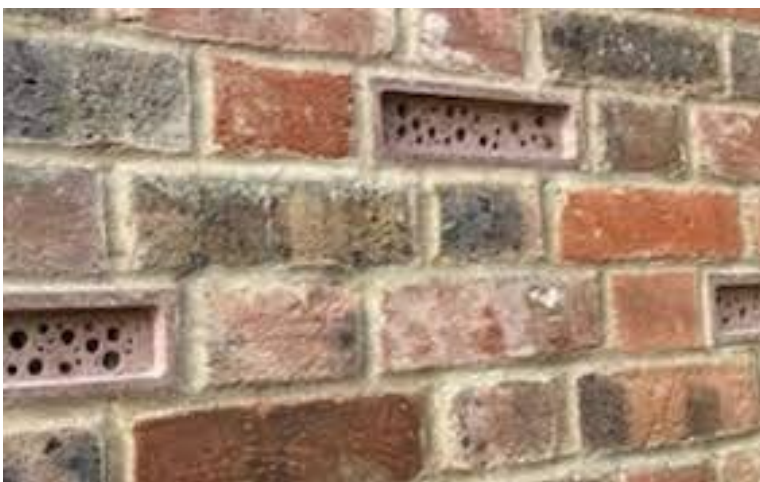
It is recommended that a total of 20 bee bricks are installed in the fabric of the new building. These bricks should be installed as high as possible with two on the southern elevation of each dwelling. As with the swift bricks, these features should be integrated into the building to prevent future interference.

These products only attract solitary bees and do not therefore cause any problems to the householder. Solitary bees have no queen or honey to protect and as a result are non-aggressive and won't sting.

Fig. 7: Examples of appropriate bee brick products.

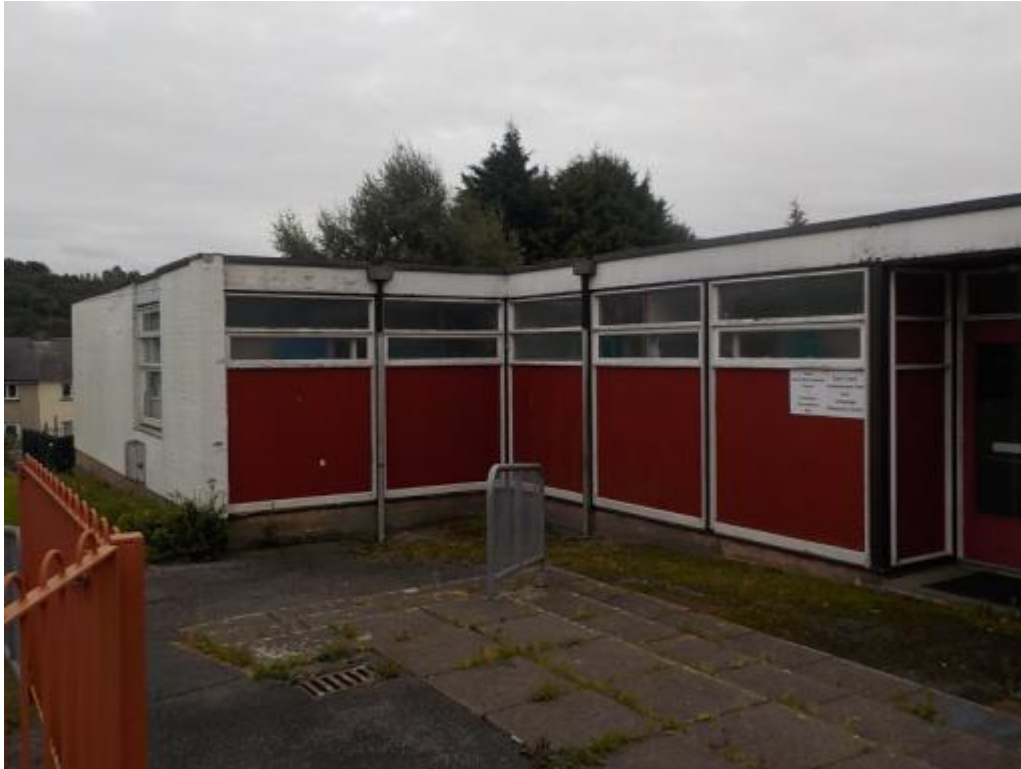
The current school buildings are all brick-built, flat-roof structures, with no crevices in the brickwork. There is a central section, with a high ceiling above the school hall, which has slate cladding on the upper half of the exterior. The flat roofs are heavy duty roofing felt, with lead flashing around the top of the wall. There are a few gaps where it is bagging away from the walls, but no other crevices.

Flat roof sections of the school buildings

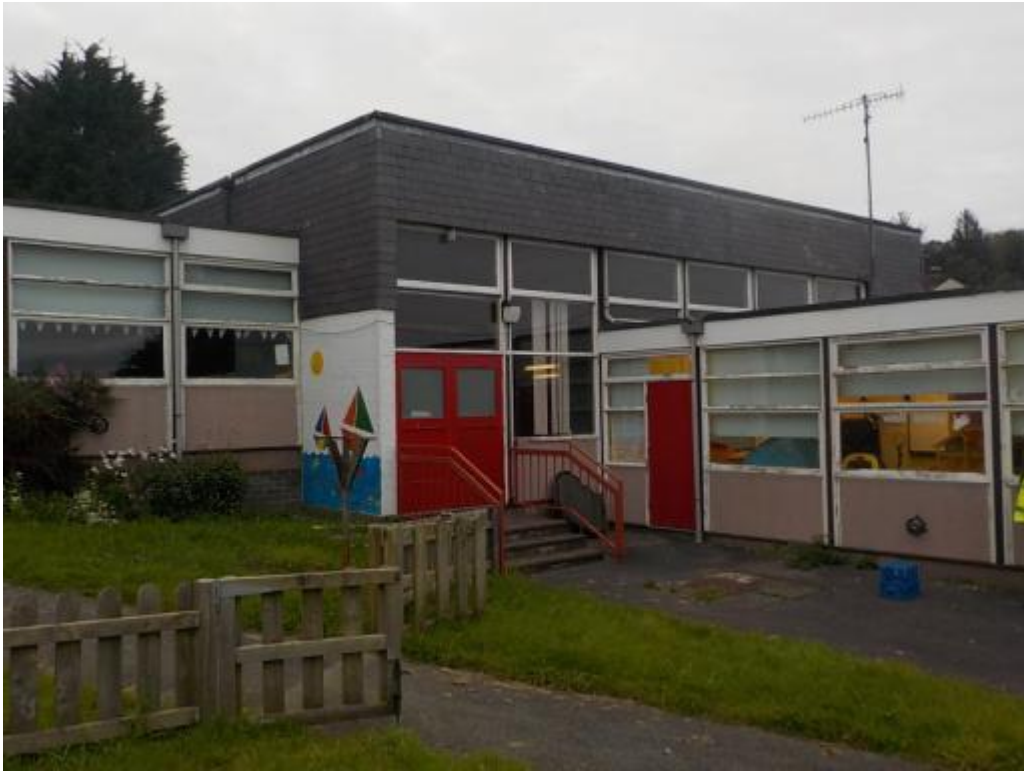
Higher section of the school hall

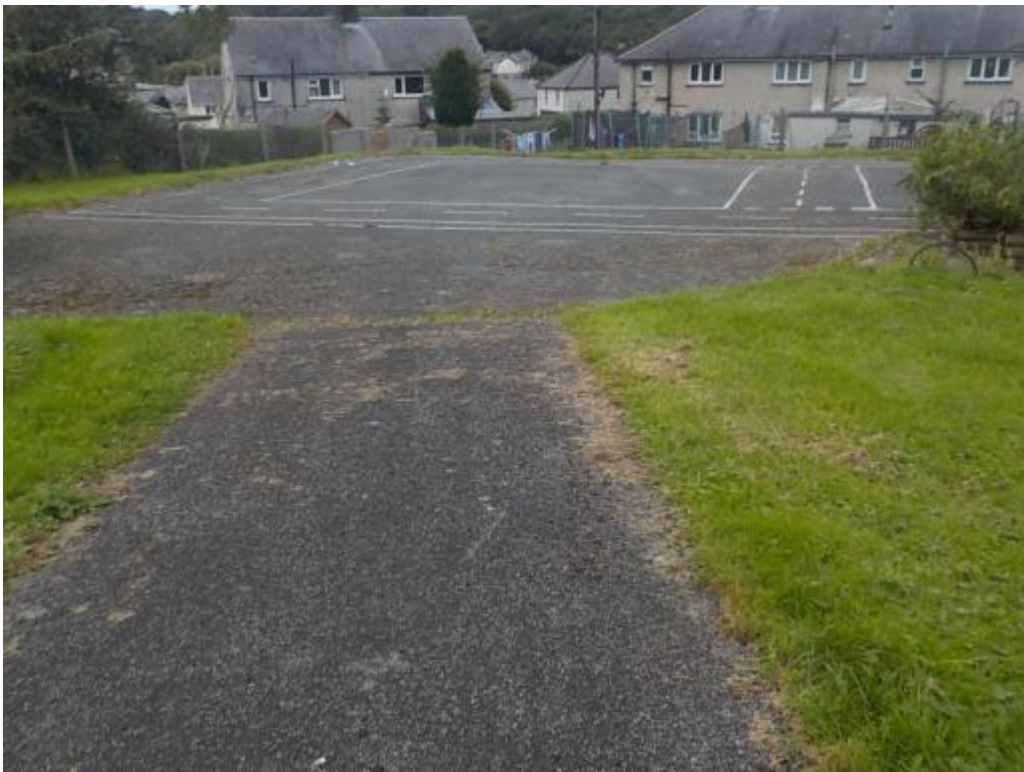
There are no species associated with these areas and no biological interest.

Hard standing playground and amenity grassland area

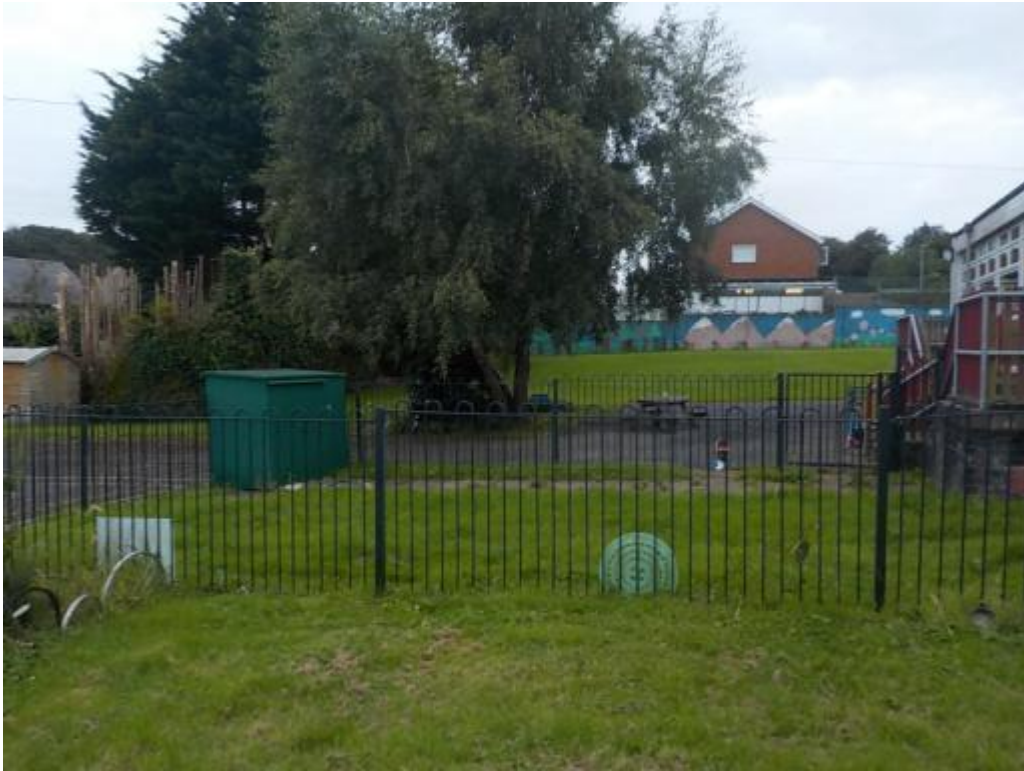
The single mature birch tree on the site has no features that offer any bat roosting potential.

Single birch tree, with Montbretia present beneath it

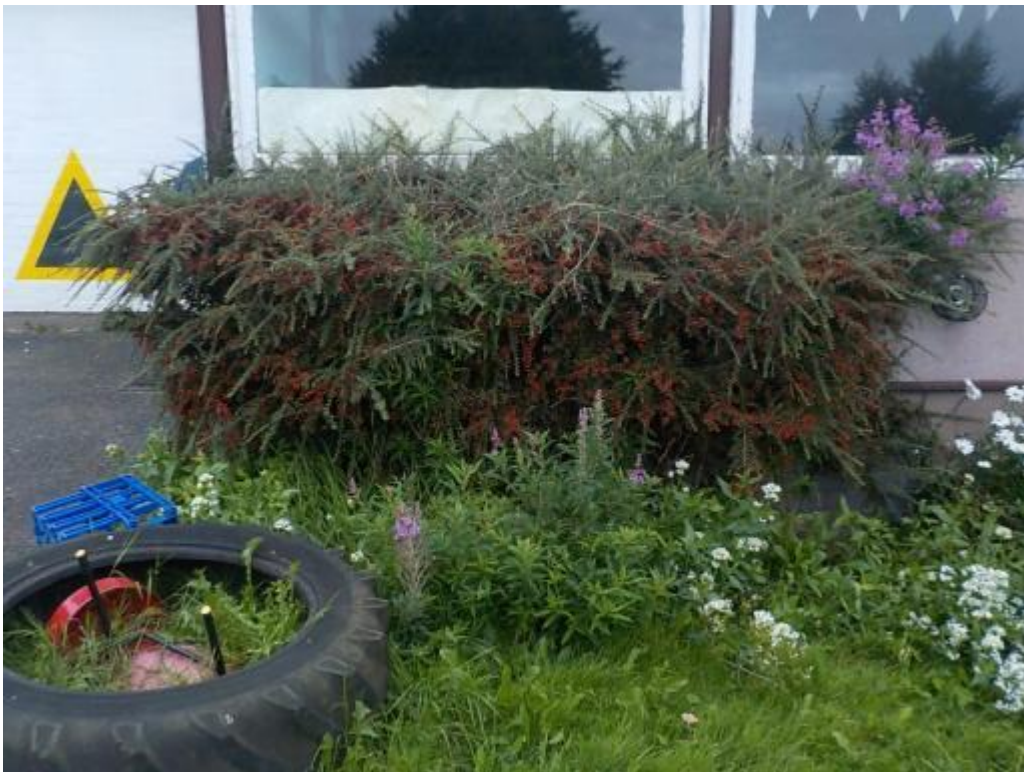
One concern is the presence of Montbretia and Rockspray cotoneaster as these species are classed as an INNS under the Wildlife & Countryside Act. While it is not illegal to grow species such as these in a garden situation, it is illegal to cause, or allow these species to spread into the wild. In this case there is the potential for the species to be

Rockspray cotoneaster

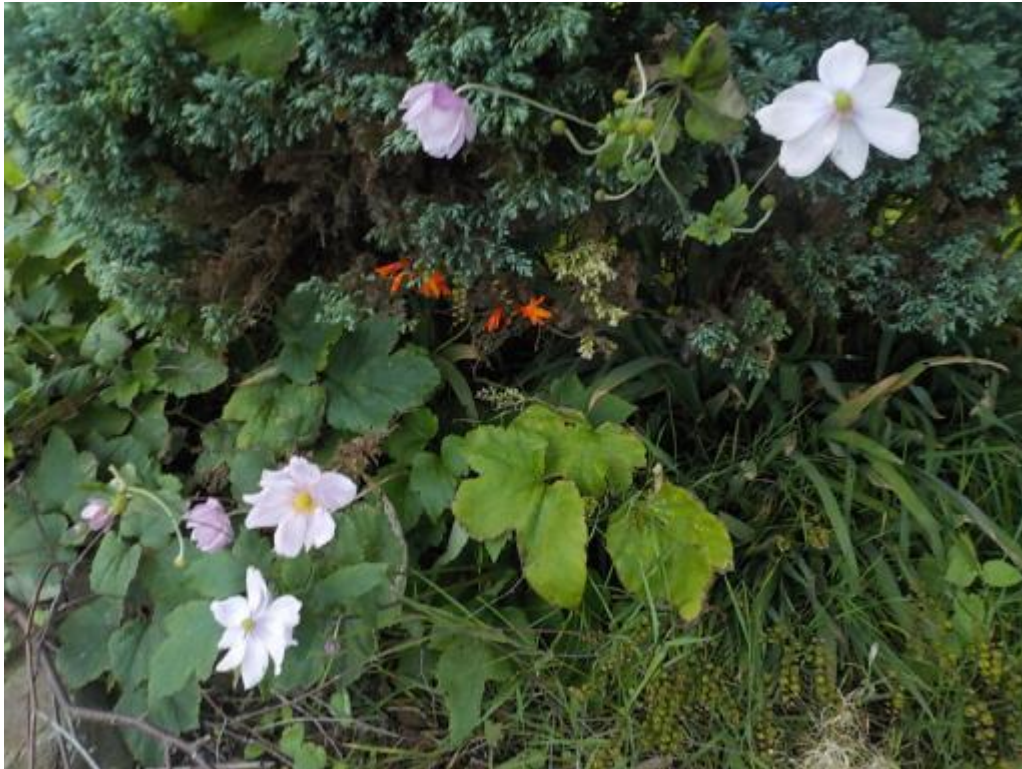
Small patch of Montbretia (orange flowers)
